# CCVT'S CLEAN WATER PROJECT

## GY Vineyard Demonstration Site Summary

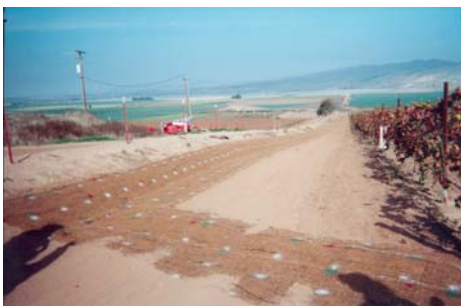
(Demo Area Prior to BMP)

<b>Historical Erosion Issues:</b>	There are many bare roads within the vineyards that are eroding.
<b>Demonstration Site Goals:</b>	Reduce erosion along several of the bare roads.
<b>Best Management Practice (BMP) Implementation:</b>	Drill sheeps and hard fescue along the roads at a rate of 35 lbs/acre. Cover with and tack down jute netting.
<b>Demo Site Acreage:</b>	5
<b>Year 1 BMP Imp. &amp; Main. Cost:</b>	NA <sup>1</sup>
<b>Year 1 BMP Imp. &amp; Main. Cost (per acre):</b>	NA
<b>Year 2 BMP Imp. &amp; Main. Cost:</b>	\$643.50
<b>Year 2 BMP Imp. &amp; Main. Cost (per acre):</b>	\$128.70

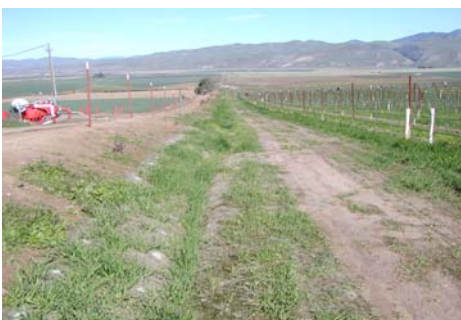
(Demo Area After BMP)

<b>Challenges Associated with Implementation of BMP:</b>	None.
<b>Challenges with Maintaining BMP:</b>	Keeping traffic to a minimum while the seeds were getting established.
<b>Misc. Challenges Associated with the Demonstration Site:</b>	Very little rain. Made it difficult for the seeds to come up.
<b>Success of BMP:</b>	Coverage of bare roads increased from 10 to 70 and 80%.
