CCVT'S CLEAN WATER PROJECT

HS Vineyard Demonstration Site Summary

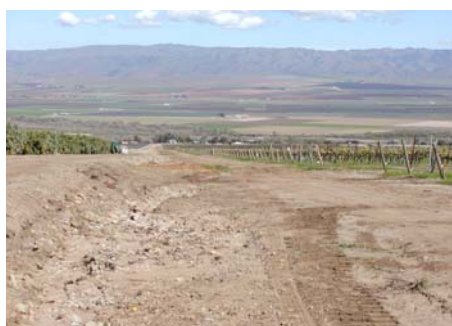
(Demo Area Prior to BMP)

Historical Erosion Issues:	Major erosion next to a mile long, bare, dirt road that runs adjacent to the vineyard.
Demonstration Site Goals:	To further reduce erosion caused from the road.
Best Management Practice (BMP) Implementation:	Hydroseed a third of the road with a perennial mix at a rate of 35 lbs/acre and blow straw on top. Hydroseed a third of the road with the same mix, same rate, no cover. Drill a third of the same mix at a rate of 35 lbs/ac.
Demo Site Acreage:	100
Year 1 BMP Imp. & Main. Cost:	\$12,913.00
Year 1 BMP Imp. & Main. Cost (per acre):	\$129.13
Year 2 BMP Imp. & Main. Cost:	Approximately \$10,000.00
Year 2 BMP Imp. & Main. Cost (per acre):	Approximately \$100.00

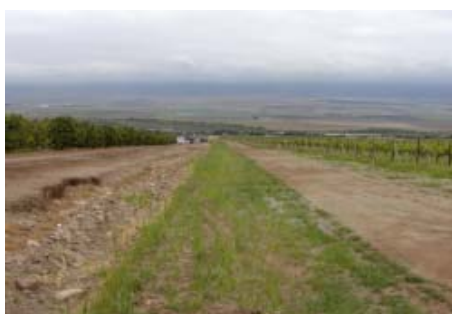
(Demo Area After BMP)

Challenges Associated with Implementation of BMP:	Significant time went into the planning of the BMP prior to implementation.
Challenges with Maintaining BMP:	Immediately after planting the road was driven on by several field workers. Portions of the planted road was removed because of this. Therefore, seeds could not get established.
Misc. Challenges Associated with the Demonstration Site:	There was very little rain during the time the seeds were trying to get established. This made it harder for the seeds to come.
Success of BMP:	Portions of the road increased coverage from 0 to 50 %.
