CCVT'S CLEAN WATER PROJECT

PCK Vineyard Demonstration Summary

Clean Water Project Summary

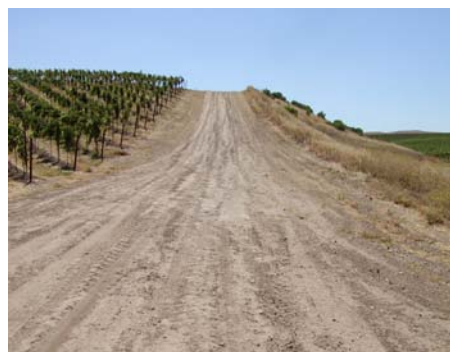
(Demo Area Prior to BMP)

Historical Erosion Issues: The vineyard is located down gradient of Highway 101. Water runs off the Hwy through the vineyard creating numerous channels and gullies. In addition, the clays and clay loams cause the ground to saturate quickly during storm events causing puddles up to several feet deep.

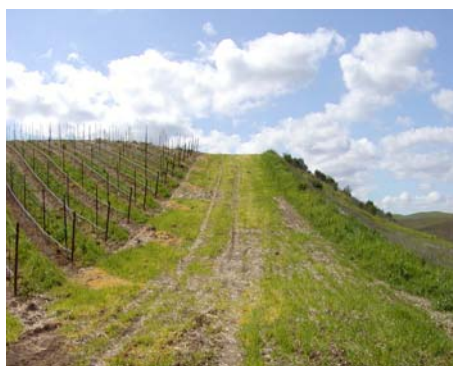
(Demo Area After BMP)

Success of BMP: The barley came up to heights of 6 to 12 inches, and covered approximately 20 to 40% of the area.

Best Management Practice (BMP) Implementation: Hand broadcast barley at a rate of 90 lbs/acre along road. Cover with straw.
