CCVT'S CLEAN WATER PROJECT

VG Vineyard Demonstration Site Summary

Clean Water Project Summary

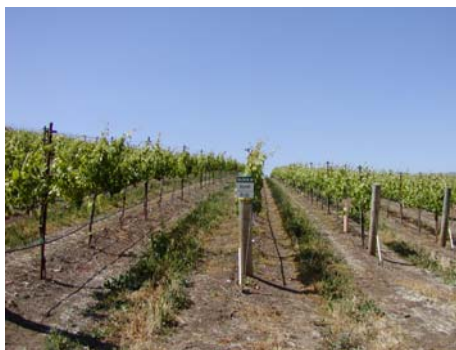
(Demo Area Prior to BMP)

Historical Erosion Issues:	Soil and water runoff from vinerows on hills.
Demonstration Site Goals:	To reduce runoff and improve soil tilth from hillside vines.
Best Management Practice (BMP) Implementation:	Drill a legume mix (bell beans, dundale peas, common vetch) on one of the blocks at a rate of 110 lbs/ac.
Demo Site Acreage:	4
Year 1 BMP Imp. & Main. Cost:	\$695.00
Year 1 BMP Imp. & Main. Cost (per acre):	\$173.75
Year 2 BMP Imp. & Main. Cost:	\$695.00
Year 2 BMP Imp. & Main. Cost (per acre):	\$173.75

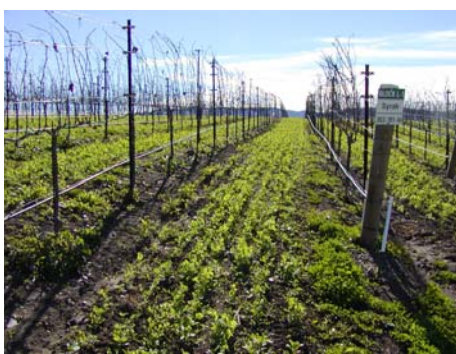
(Demo Area After BMP)

Success of BMP:	The cover crop came up to heights between 8 and 12 inches and covered approximately 80 to 90% of the area.
------------------------	--

RUSLE² 2 Score (soil loss):	(Tons/Acre/Year)	(Tons/Demo Site)
Before BMP Implementation:	3	12
After BMP Implementation:	1.5	6
Decrease:	1.5	6
