CCVT'S CLEAN WATER PROJECT

BR Vineyard Demonstration Site Summary

Clean Water Project Summary

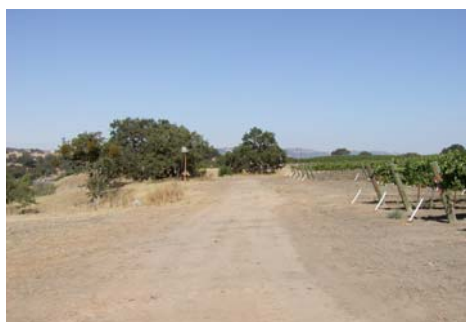
(Demo Area Prior to BMP)

Historical Erosion Issues:	There are many bare roads within the vineyards. Several of the bare roads are eroding and contribute to the culverts along the back of the vineyard.
Demonstration Site Goals:	Reduce erosion along the roads and in nearby culverts.
Best Management Practice (BMP) Implementation:	Drill a perennial road mix along the back roads and sides at a rate of 25 lbs/acre. Cover with straw.
Demo Site Acreage:	5
Year 1 BMP Imp. & Main. Cost:	NA ¹
Year 1 BMP Imp. & Main. Cost (per acre):	NA
Year 2 BMP Imp. & Main. Cost:	\$607.00
Year 2 BMP Imp. & Main. Cost (per acre):	\$121.40
Challenges and Successes	
Challenges Associated with Implementation of BMP:	None.
Challenges with Maintaining BMP:	Keeping traffic to a minimum along the road while the seeds were getting established.
Misc. Challenges Associated with the Demonstration Site:	There was very little rain during the time that the seeds were trying to get established. In addition, very little water was applied to the area.

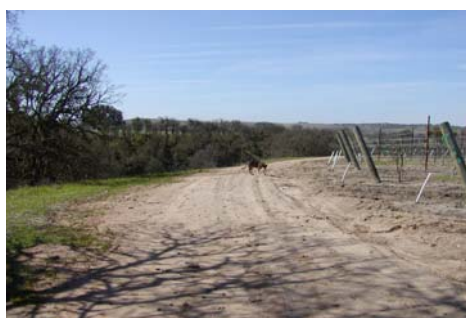
(Demo Area After BMP)

Success of BMP:	The seeds planted along the sides of the road got established and came up to heights between 6 and 12 inches. Coverage of the sides was between 40 and 50%.
