CCVT'S CLEAN WATER PROJECT

SM Vineyard Demonstration Site Summary

Clean Water Project Summary

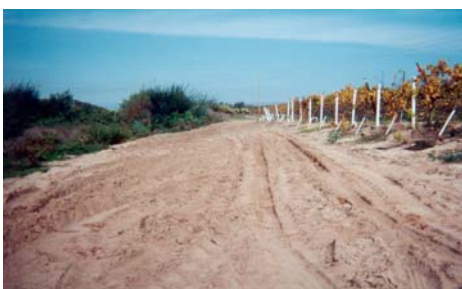
(Demo Area Prior to BMP)

Historical Erosion Issues:	The vineyard is planted on sandy "sugar" soils. As a result there is a lot of sediment runoff and buildup in the lower areas.
Demonstration Site Goals:	To reduce sediment loss from one of the roads into a nearby creek bed.
Best Management Practice (BMP) Implementation:	Grade the road to create a flatter surface. Broadcast sheep and hard fescue along the road at a rate of 35 lbs/acre. Cover with and tack down jute netting.
Demo Site Acreage:	2
Year 1 BMP Imp. & Main. Cost:	\$1,285.00
Year 1 BMP Imp. & Main. Cost (per acre):	\$642.50
Year 2 BMP Imp. & Main. Cost:	\$399.00
Year 2 BMP Imp. & Main. Cost (per acre):	\$199.50

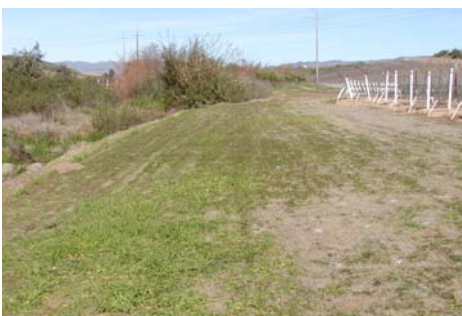
(Demo Area After BMP)

Challenges Associated with Implementation of BMP:	Time. The seeds were hand broadcasted and the jute netting had to be secured by hand.
Challenges with Maintaining BMP:	None.
Misc. Challenges Associated with the Demonstration Site:	There was very little rain during the times the seeds were trying to get established. In addition, very little water was applied to the area.
Success of BMP:	The fescues grew to heights of 2 to 10 inches and covered approximately 60 to 80% of the area.

RUSLE² 2 Score (soil loss):	(Tons/Acre/Year)	(Tons/Demo Site)
Before BMP Implementation:	32.5	65
After BMP Implementation:	0.75	1.5
Decrease:	31.75	63.5
