GRAPEGROWING

January/February 2005

BY Dawn Stimson, Clean Water Project Coordinator, Central Coast Vineyard Team,

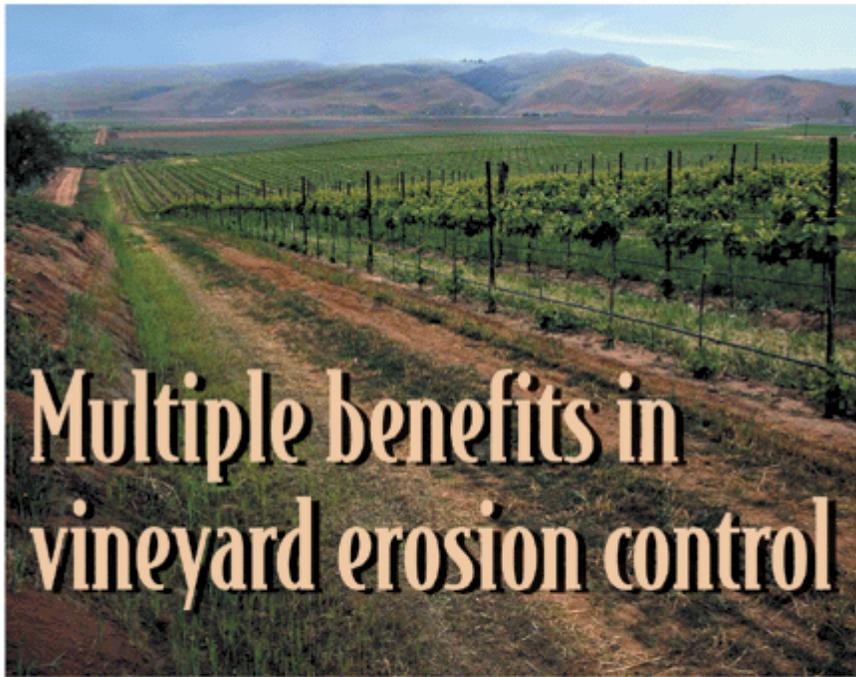
BMP practices were implemented along this road at a Santa Maria, CA, demonstration site to help reduce soil and water runoff, including road grading (to remove rills and gullies), seeding with fescues and Juan triticale (along the fence), and use of jute netting. (Photo by Marilyn Brooks)

In the summer of 2003, roads were smoothed over an area equivalent to 10 acres. Gullies and rills were removed. Following harvest, the roads were seeded to establish cover crop and reduce runoff. A mix of sheep fescue (*Festuca ovina*) and hard fescue (*Festuca longifolia*) was selected because of its drought tolerance, longevity (as a perennial), and deep-rooting properties. The fescue mix was drilled along the roads at 30 pounds per acre (lbs/acre).

Straw was spread on top of the road at one ton per acre (approximately one to two inches deep) to secure the seeds against the first rains. In one area more susceptible to erosion, jute netting was secured on top of the road for additional support to the seeds. Along the fence beside a couple of roads, triticale was planted as a filter strip to slow water run-off from the adjacent property. Triticale was selected because of its early ripening and large yielding capacity and was broadcast at 90 lbs/acre.

Many benefits were evident through implementing selected BMPs along these demonstration roads: an increase in cover from 10% to 75%, a reduction in soil leaving the roads, and reduced re-grading expenditures.

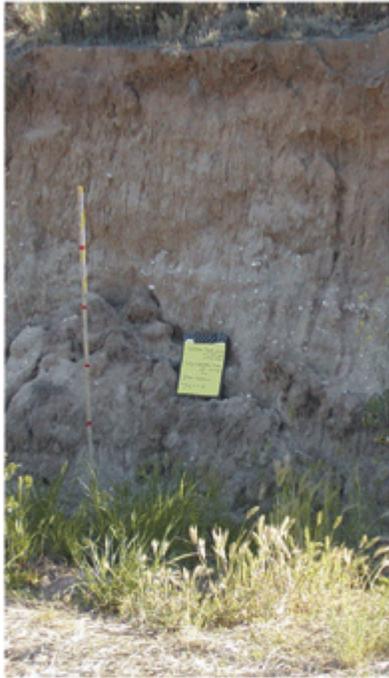
Historically, this road cut (approximately seven-feet deep) eroded during the rainy season, depositing several feet of soil onto a nearby vineyard that had to be manually removed each year. BMP implementation included grading and planting of barley and fescues to reduce erosion and stabilize the area. (Photo by Dawn Stimson)

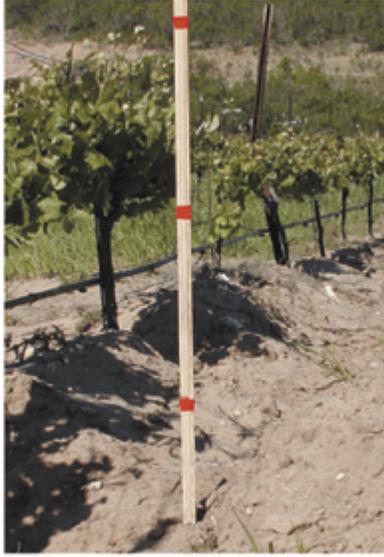
Approximately 1.5 feet of soil built up along vines as a result of an eroding road cut uphill. (Photo by Dawn Stimson)

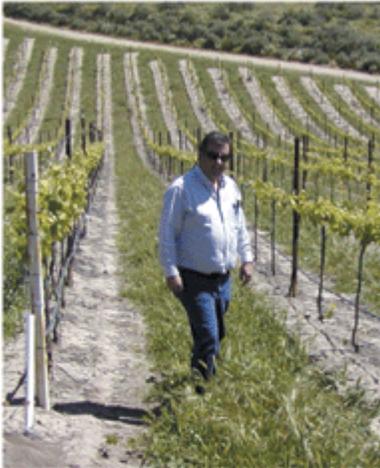
Kevin Merrill, vineyard manager, in a newly planted demonstration block with a perennial erosion cover crop mix (crimson clover, rose clover, subterranean clover, medic, Persian clover, dwarf perennial ryegrass, and fine fescues) drilled at 35 lbs./acre. (Photo by Dawn Stimson)

The area was divided into four blocks. One block was drilled with 35 lbs/acre of Perennial Erosion Mix⁶ of crimson clover, rose clover, subterranean clover (*Trifolium subterraneum*), medic (*Medicago*), Persian clover, dwarf rye grass, and fine fescues. Another block was drilled with 35 lbs/acre of Drought Annual Mix (crimson clover, rose clover, subterranean clover, medics, Persian clover).⁶ A third block was divided in two sections. The upper most half of the block was drilled with 80 lbs/acre of Juan triticale (*Triticosecale Wittm*). The lower half of the block was drilled with 10 lbs/acre of Zorro fescue, as was the fourth block.

Benefits of implemented BMPs were seen in each of the subplots. The Perennial Erosion Mix grew to heights of eight to 12 inches and covered about 85% of the planted area. The Annual Erosion Mix grew six to eight inches in height and covered about 50% to 60% of the area. Juan triticale grew to 18 to 36 inches in height and covered almost 90% of the planted area. Zorro fescue grew four to six inches and covered about 50% of the planted area (lack of better establishment may
